**Flood Control Project Maintenance
Levee Inspections
LMA District Cover Sheet
Spring 2012 Levee Inspection Results**

Reclamation District No. 0003 Grand Island

Spring 2012 Levee Inspection Results

Waterway	Bank	Unit Miles
Unit No. 01 Left Bank Steamboat Slough	Left	11.03

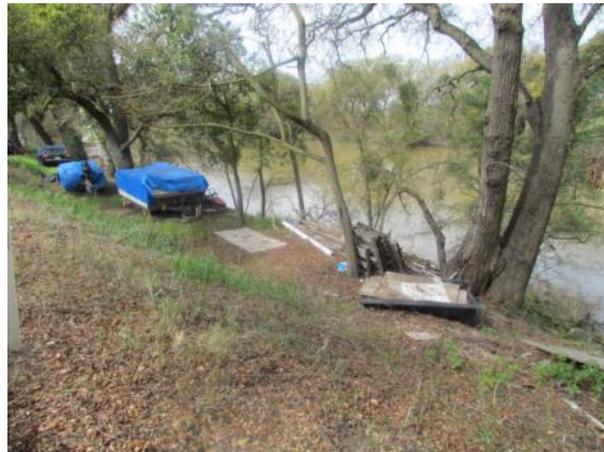
Levee Mile Report Line	5
Start Levee Mile	0.21
End Levee Mile	0.21
Location	Water Side
Category	Earthen Levee
Item	Encroachments
Looking southwest at trash on waterside berm.	
richard_s_20120328_182.jpg

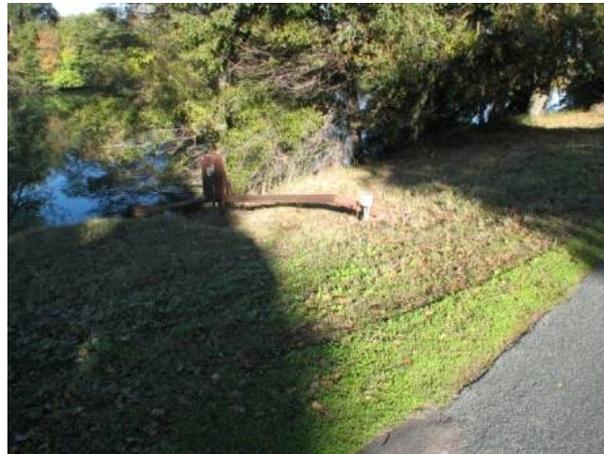
Levee Mile Report Line	11
Start Levee Mile	0.97
End Levee Mile	0.97
Location	Crown
Category	Earthen Levee
Item	Encroachments
Irrigation intake pipe from Steamboat Slough.	
richard_s_20120313_161.jpg

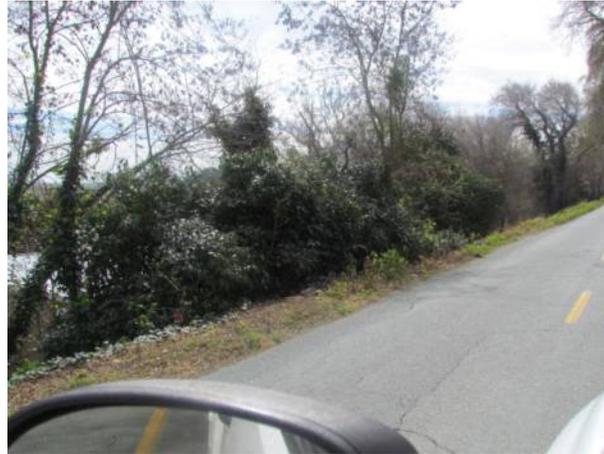
Looking southeast at landscaping on landside slope.

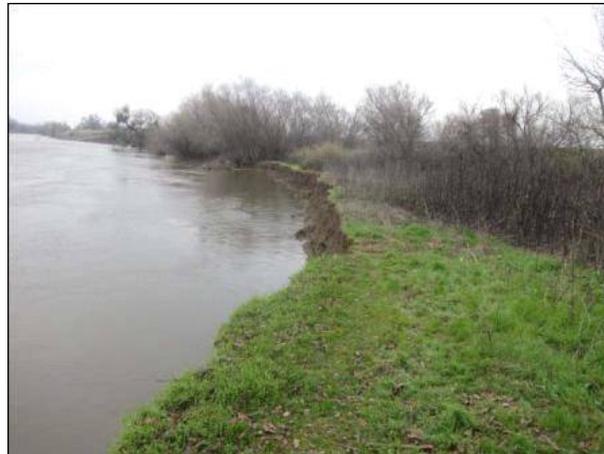
Looking northeast at dense vegetation on waterside slope.

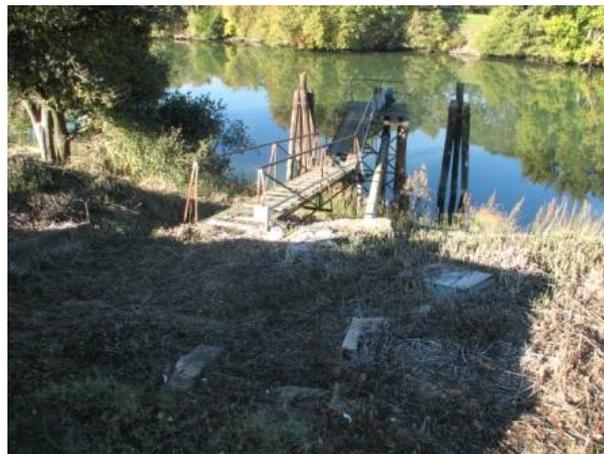
Irrigation pipe penetration.

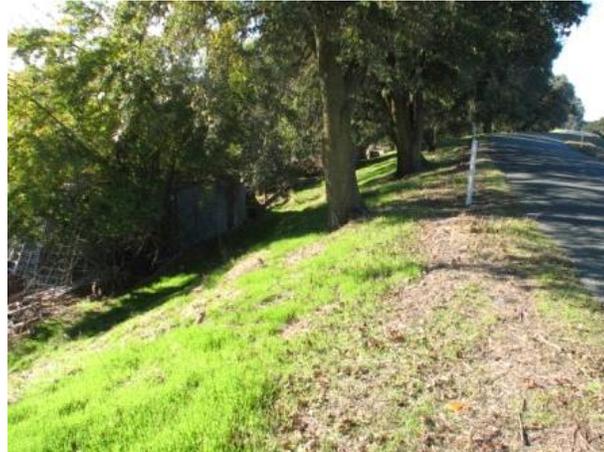
Levee Mile Report Line	16
Start Levee Mile	1.40
End Levee Mile	1.40
Location	Land Side
Category	Earthen Levee
Item	Encroachments
Equipment within 10' of levee toe obstructs access and visibility.	
richard_s_20120313_164.jpg

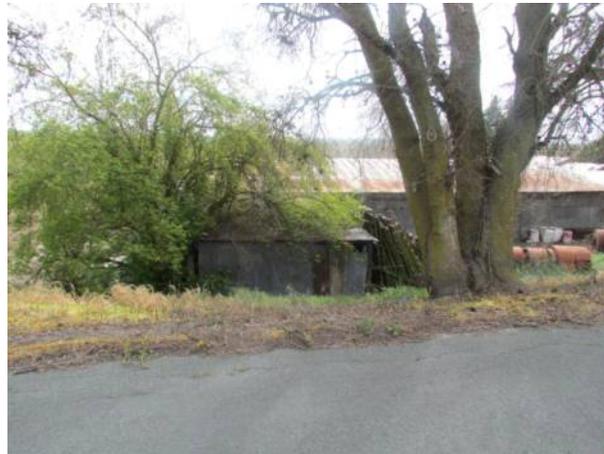
Levee Mile Report Line	16
Start Levee Mile	1.40
End Levee Mile	1.40
Location	Land Side
Category	Earthen Levee
Item	Encroachments
Looking east at tool shed and equipment on landside toe.	
richard_s_20120328_185.jpg

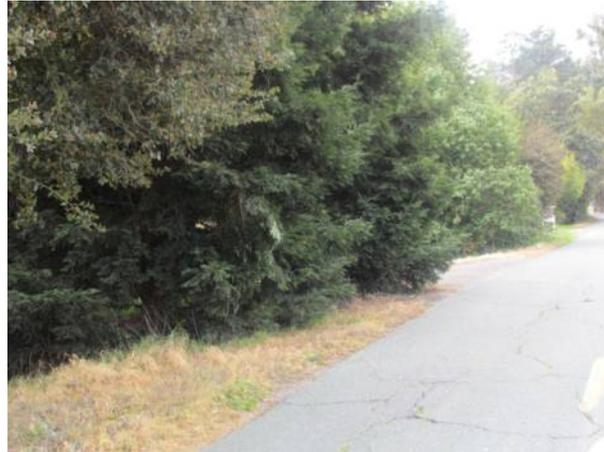
Levee Mile Report Line	17
Start Levee Mile	1.60
End Levee Mile	1.60
Location	Land Side
Category	Earthen Levee
Item	Vegetation
Looking southeast at dense trees on landside shoulder and slope. (updated Spring 2012)	
richard_s_20120328_186.jpg

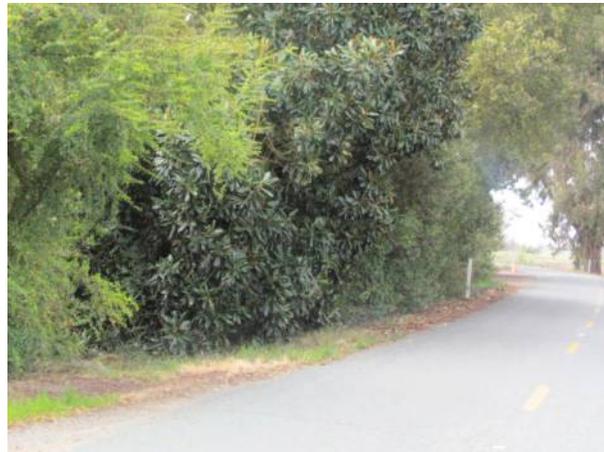
Levee Mile Report Line	18
Start Levee Mile	1.61
End Levee Mile	1.61
Location	Land Side
Category	Earthen Levee
Item	Vegetation
Looking south at dense landscaping on landside shoulder and slope.	
richard_s_20120328_187.jpg

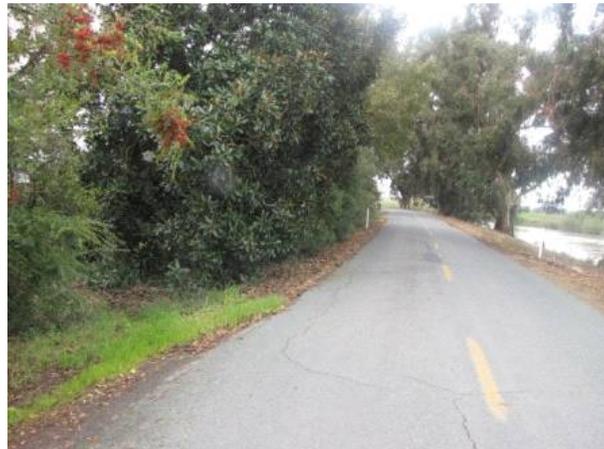
Levee Mile Report Line	20
Start Levee Mile	1.64
End Levee Mile	1.66
Location	Land Side
Category	Earthen Levee
Item	Vegetation
Looking southwest at dense landscaping on landside shoulder and slope.	
richard_s_20120313_150.jpg

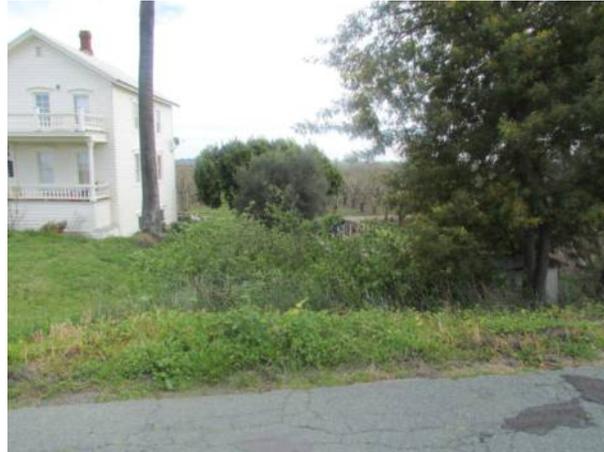
Looking east at vegetation on landside slope.

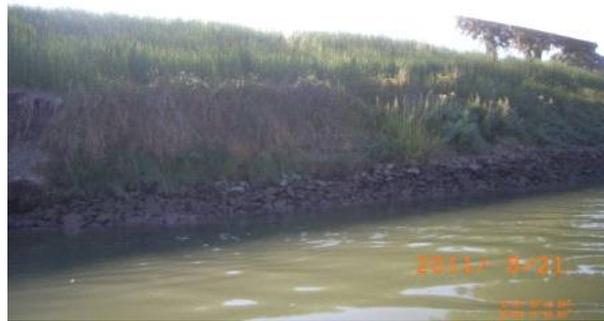
USACE 2011 Photo #1

LMR No.	Levee Mile		Category	Item	Location	Rating	Action/Comment	GPS Latitude/Longitude		Issue No. Photo
	Start	End						Start	End	
24	2.05	2.05	Supplemental	USACE Erosion Survey	WS	U Ma	Inspector Comments: 2009 - Slumping at the levee toe , cobbles at the downstream end. 2010 - Very steep new vertical slump, short site, but looked bad. 2011: This site is upgraded to CRITICAL. A section of rock has failed. Significant new erosion, bank is vertical almost to the top of the levee. Levee has a road on top that is used by trucks and heavy farm equipment. [2011 Site ID: STM_23-8_L]	38.277261 ° -121.590039 °	38.277595 ° -121.589773 °	21 Y
DWR ID: DWR_RD0003_01_s_2012_21										
25	2.07	2.07	Earthen Levee	Encroachments	WS	M En	PI : Pipe Inspector Comments: Pump shed on waterside slope.	38.278615 ° -121.588727 °	38.278615 ° -121.588727 °	36 Y
DWR ID: DWR_RD0003_01_s_2012_36										
26	2.14	2.14	Earthen Levee	Encroachments	WSA/W	PI : Pipe Ma		38.277722 ° -121.589389 °	38.277722 ° -121.589389 °	37 Y

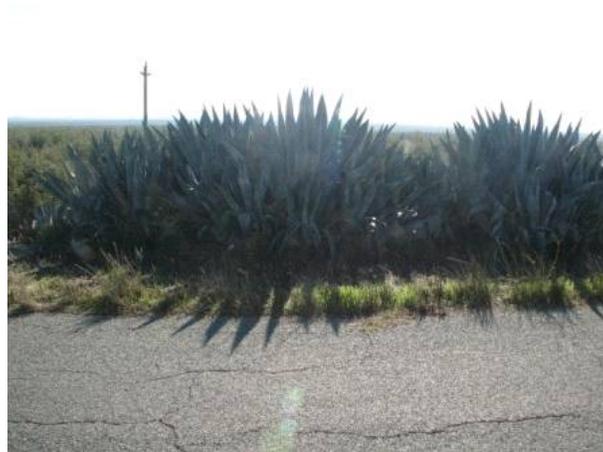
Levee Mile Report Line	35
Start Levee Mile	3.33
End Levee Mile	3.33
Location	Land Side
Category	Earthen Levee
Item	Vegetation
Large cactus on upper levee slope obstructs access and visibility.	
richard_s_20120313_167.jpg

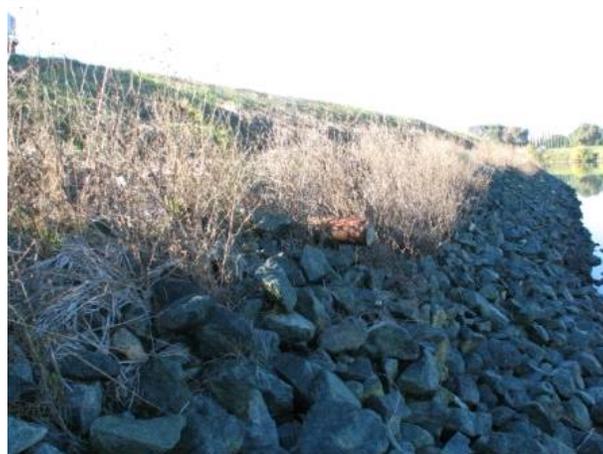
Levee Mile Report Line	36
Start Levee Mile	3.52
End Levee Mile	3.52
Location	Crown
Category	Earthen Levee
Item	Encroachments
Abandoned pipe penetration. Pipe has been grouted.	
richard_s_20120313_168.jpg

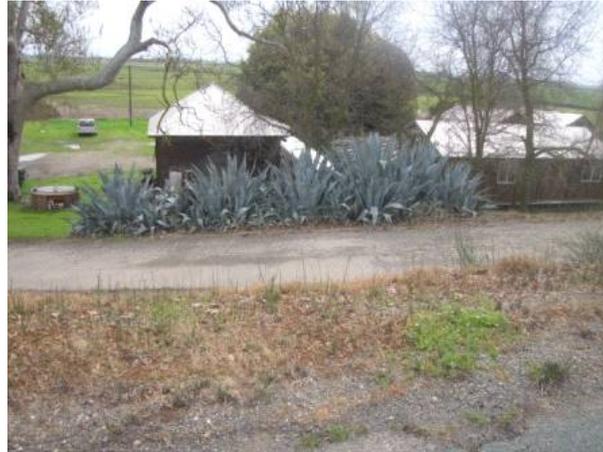
Levee Mile Report Line	46
Start Levee Mile	5.33
End Levee Mile	5.33
Location	Land Side
Category	Earthen Levee
Item	Vegetation
Looking west a century plants on landside slope next to a ramp.	
richard_s_20120313_170.jpg

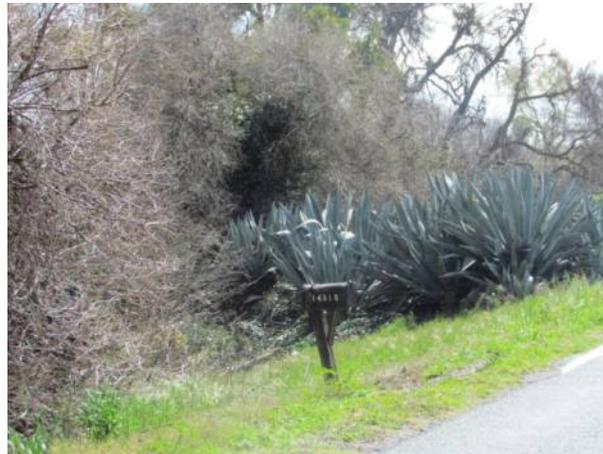
Levee Mile Report Line	48
Start Levee Mile	5.48
End Levee Mile	5.50
Location	Land Side
Category	Earthen Levee
Item	Vegetation
Looking southeast at century plants on landside shoulder and slope.	
richard_s_20120328_189.jpg

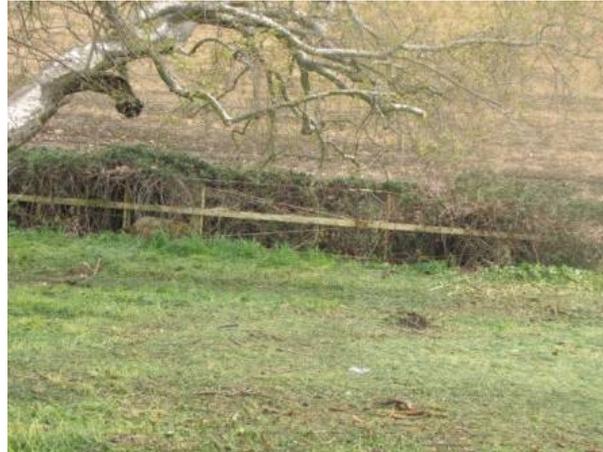
Levee Mile Report Line	51
Start Levee Mile	5.70
End Levee Mile	5.70
Location	Land Side
Category	Earthen Levee
Item	Encroachments
Looking east at dense vegetation covering farm equipment on landside toe.	
richard_s_20120313_171.jpg

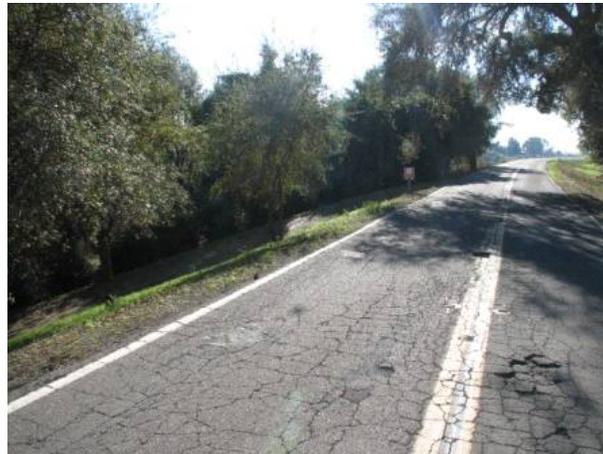
Levee Mile Report Line	52
Start Levee Mile	5.76
End Levee Mile	5.76
Location	Land Side
Category	Earthen Levee
Item	Vegetation
Landscaping on levee slope and within 10' of levee toe obstruct visibility and access.	
richard_s_20120313_172.jpg

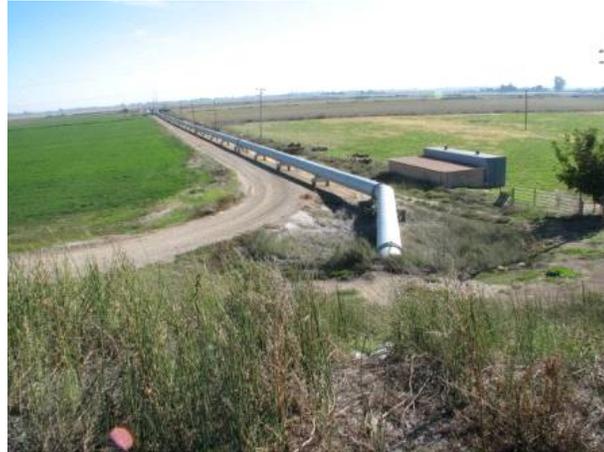
Levee Mile Report Line	56
Start Levee Mile	6.76
End Levee Mile	6.76
Location	Land Side
Category	Earthen Levee
Item	Encroachments
Interior drainage discharge pipe penetrates levee.	
richard_s_20120313_173.jpg

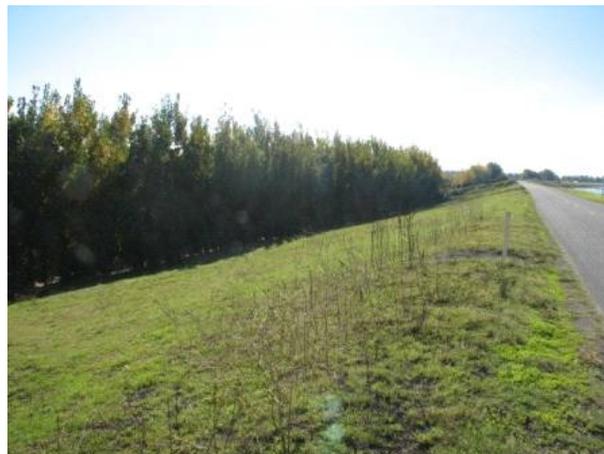
Trees within 10' of levee toe obstruct access and visibility of levee toe.

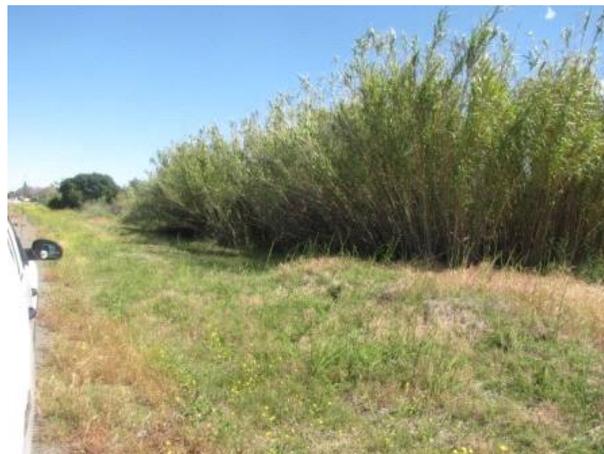
Levee Mile Report Line	4
Start Levee Mile	0.31
End Levee Mile	0.33
Location	Water Side
Category	Earthen Levee
Item	Vegetation

Looking northeast at bamboo on waterside slope.

DWR ID: DWR_RD0003_02_s_2012_4									
4	0.31	0.33	Earthen Levee	Vegetation	WSA/W Ma	V2 : Remove the wild growth other than native grasses from the levee slopes.	38.174281 ° -121.648698 °	38.174209 ° -121.648352 °	5 Y
DWR ID: DWR_RD0003_02_s_2012_5									
5	0.40	0.40	Earthen Levee	Slope Stability	WSA/W Ma	S2 : Repair the levee slope damaged by foot traffic and prevent access where possible. Inspector Comments: District repaired slope damage cause by foot traffic.	38.173989 ° -121.647142 °	38.173989 ° -121.647142 °	1 Y
DWR ID: DWR_RD0003_02_s_2012_1									
6	1.32	1.32	Earthen Levee	Encroachments	WSA/W Ma	PI : Pipe	38.171005 ° -121.631524 °	38.171005 ° -121.631524 °	39
DWR ID: DWR_RD0003_02_s_2012_39									
7	1.71	1.71	Earthen Levee	Encroachments	WSA/W Ma	PI : Pipe	38.167958 ° -121.625706 °	38.167958 ° -121.625706 °	40
DWR ID: DWR_RD0003_02_s_2012_40									
8	1.93	1.98	Earthen Levee	Vegetation	WS U En	V6 : Landscaping	38.166525 ° -121.622201 °	38.166176 ° -121.621332 °	70 Y

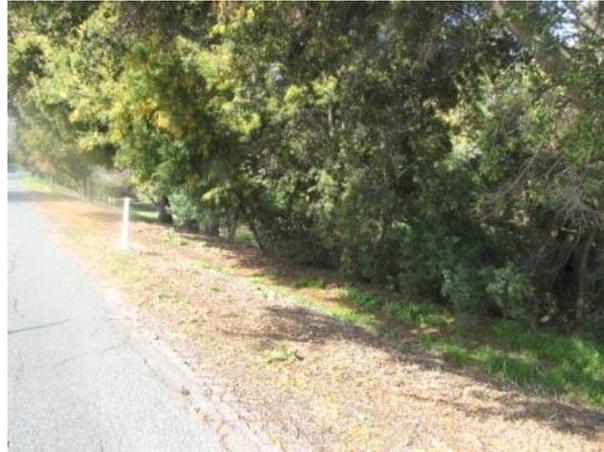
Levee Mile Report Line	13
Start Levee Mile	3.29
End Levee Mile	3.29
Location	Land Side
Category	Earthen Levee
Item	Trim / Thin Trees
Looking west at dense vegetation on landside slope and toe.	
richard_s_20120313_348.jpg

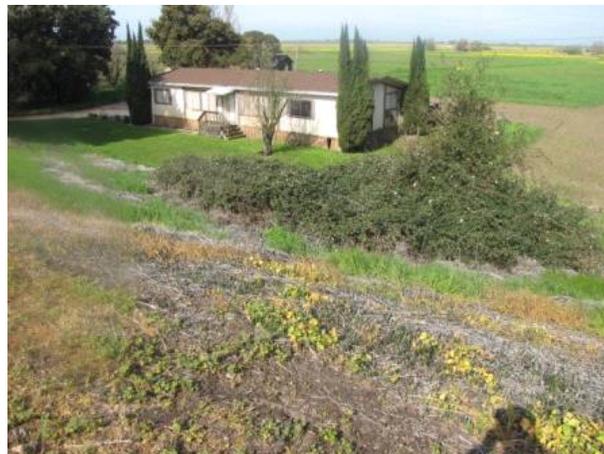
Levee Mile Report Line	14
Start Levee Mile	3.32
End Levee Mile	3.32
Location	Land Side
Category	Earthen Levee
Item	Vegetation
Looking west at berryvines on landside toe.	
richard_s_20120313_363.jpg

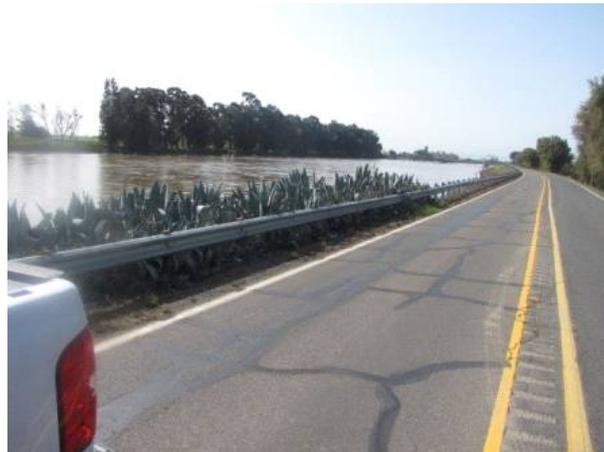
Levee Mile Report Line	21
Start Levee Mile	4.22
End Levee Mile	4.22
Location	Land Side
Category	Earthen Levee
Item	Vegetation

Looking southeast a cactus on waterside shoulder and slope.

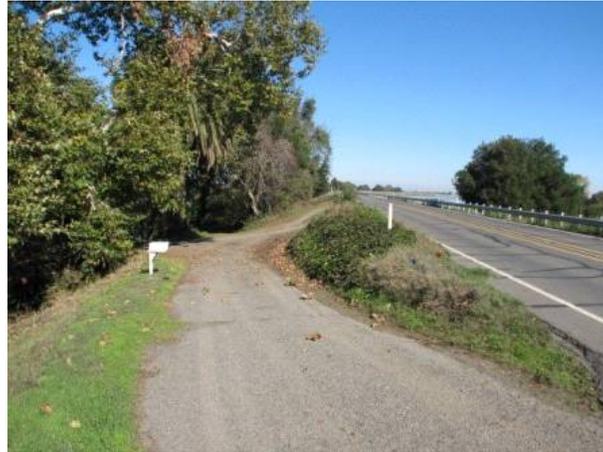
Levee Mile Report Line	24
Start Levee Mile	4.36
End Levee Mile	4.42
Location	Land Side
Category	Earthen Levee
Item	Vegetation
Landscaping on levee slope and toe obstructs access and visibility.	
richard_s_20120313_374.jpg

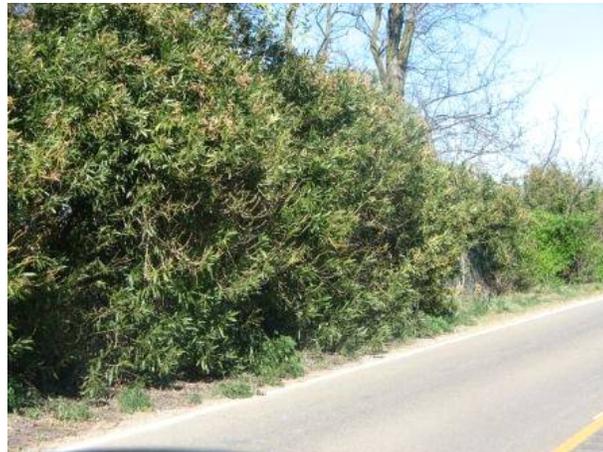
Levee Mile Report Line	31
Start Levee Mile	5.94
End Levee Mile	6.00
Location	Land Side
Category	Earthen Levee
Item	Vegetation
Oleander on landside shoulder blocking view of levee slope from LM 5.94 to 6.00	
richard_s_20120313_351.jpg

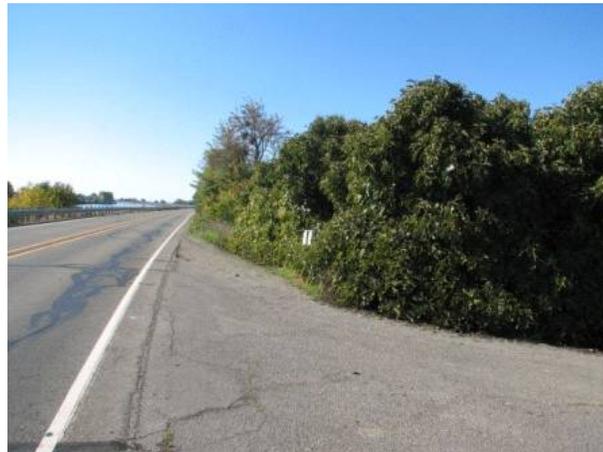
Levee Mile Report Line	31
Start Levee Mile	5.94
End Levee Mile	6.00
Location	Land Side
Category	Earthen Levee
Item	Vegetation
Landscaping on levee slope and toe obstructs access and visibility.	
richard_s_20120313_352.jpg

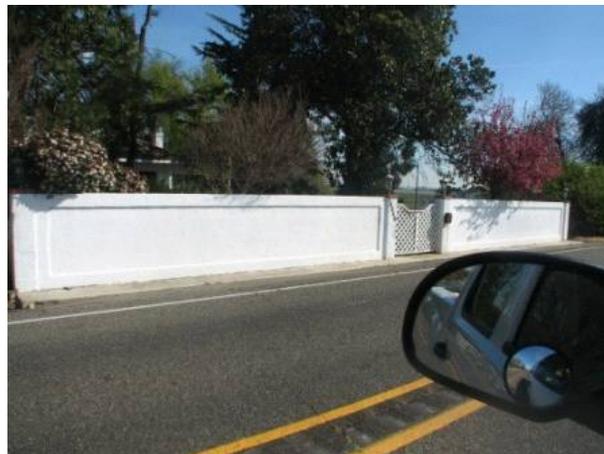
Levee Mile Report Line	50
Start Levee Mile	10.13
End Levee Mile	10.13
Location	Land Side
Category	Earthen Levee
Item	Encroachments
Block/Concrete fence on landside shoulder at LM 10.13	
richard_s_20120313_359.jpg

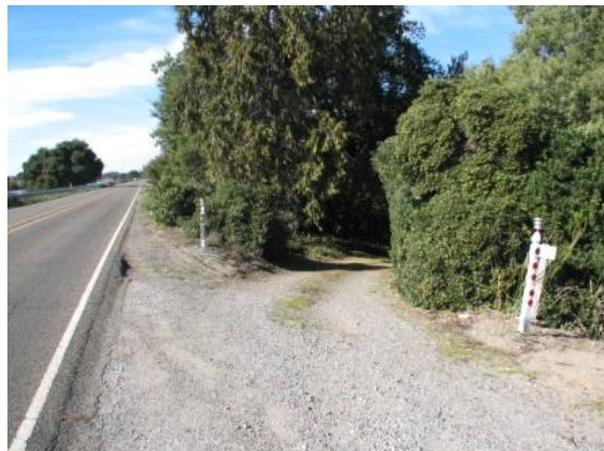
Levee Mile Report Line	53
Start Levee Mile	10.74
End Levee Mile	10.74
Location	Land Side
Category	Earthen Levee
Item	Vegetation
Landscaping on levee slope and toe obstructs access and visibility.	
richard_s_20120313_367.jpg

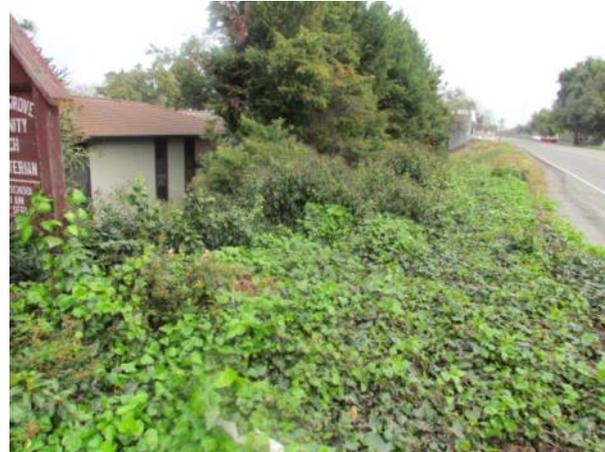
Levee Mile Report Line	61
Start Levee Mile	12.03
End Levee Mile	12.07
Location	Land Side
Category	Earthen Levee
Item	Vegetation
Looking northwest at dense landscaping on landside shoulder and slope.	
richard_s_20120328_167.jpg

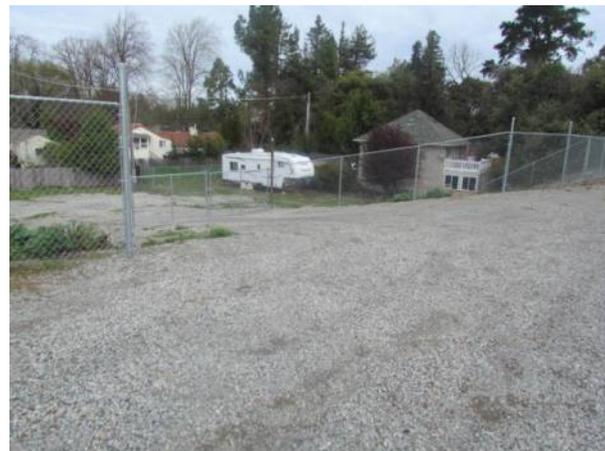
Levee Mile Report Line	62
Start Levee Mile	12.21
End Levee Mile	12.21
Location	Land Side
Category	Earthen Levee
Item	Encroachments
Looking northwest at new ramp on landside slope.	
richard_s_20120328_169.jpg

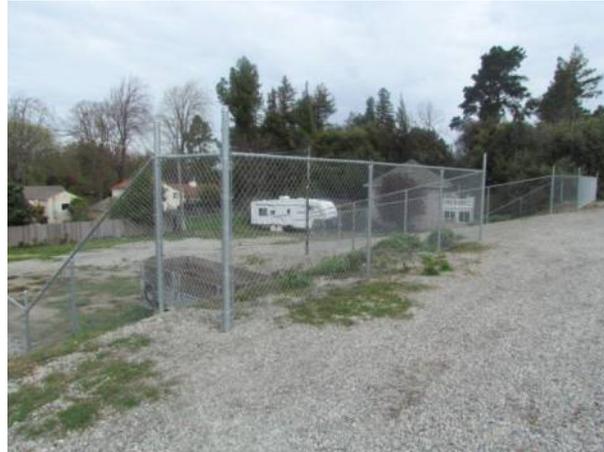
Levee Mile Report Line	63
Start Levee Mile	12.21
End Levee Mile	12.21
Location	Land Side
Category	Earthen Levee
Item	Encroachments
Looking northwest at new fence on landside shoulder and slope.	
richard_s_20120328_168.jpg

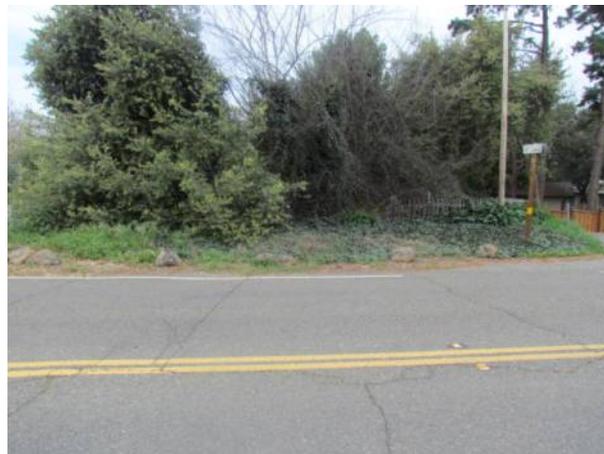
Levee Mile Report Line	64
Start Levee Mile	12.23
End Levee Mile	12.30
Location	Land Side
Category	Earthen Levee
Item	Vegetation
Looking west at dense landscaping on landside shoulder and slope.	
richard_s_20120328_170.jpg

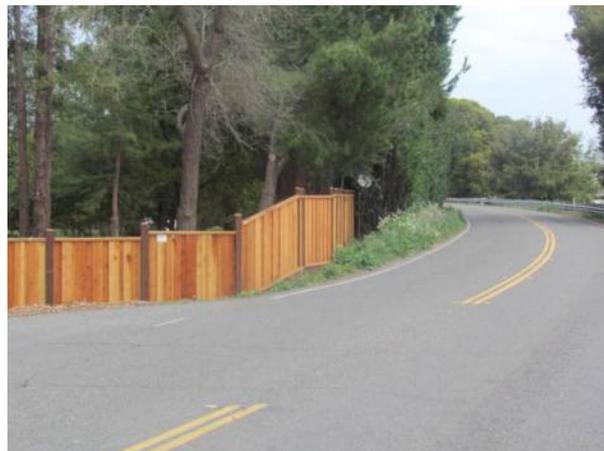
Levee Mile Report Line	65
Start Levee Mile	12.26
End Levee Mile	12.26
Location	Land Side
Category	Earthen Levee
Item	Encroachments
Looking northwest a new wooden fence on landside shoulder.	
richard_s_20120328_171.jpg

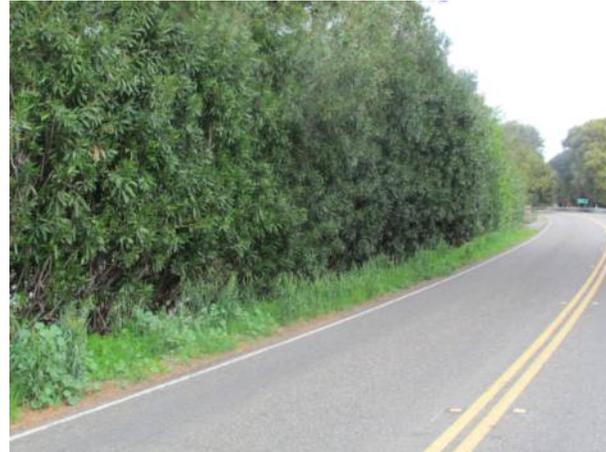
Levee Mile Report Line	66
Start Levee Mile	12.33
End Levee Mile	12.40
Location	Land Side
Category	Earthen Levee
Item	Vegetation
Looking northwest at oleander on landside shoulder.	
richard_s_20120328_172.jpg

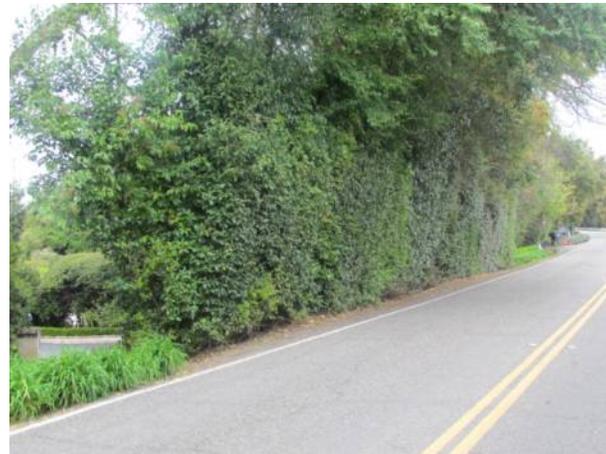
Levee Mile Report Line	67
Start Levee Mile	12.48
End Levee Mile	12.55
Location	Land Side
Category	Earthen Levee
Item	Vegetation
Looking northwest at dense landscaping on landside shoulder.	
richard_s_20120328_173.jpg

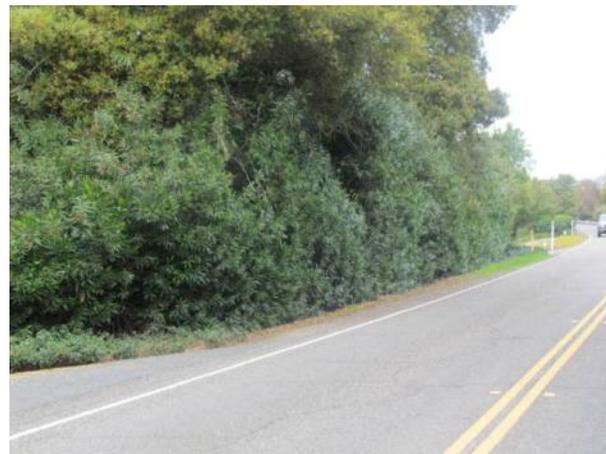
Levee Mile Report Line	69
Start Levee Mile	12.60
End Levee Mile	12.63
Location	Land Side
Category	Earthen Levee
Item	Vegetation
Looking northwest at dense landscaping on landside shoulder and slope.	
richard_s_20120328_174.jpg

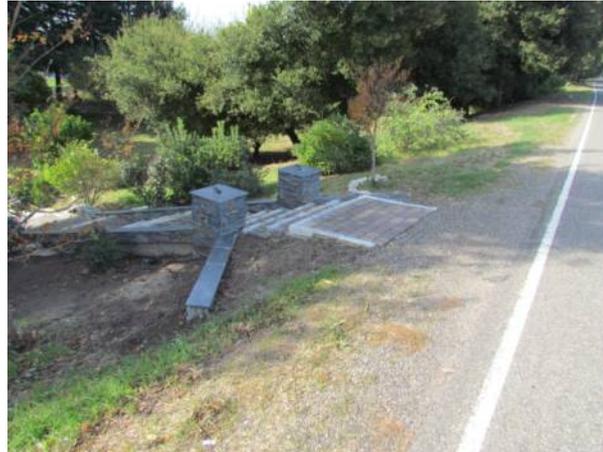
Levee Mile Report Line	75
Start Levee Mile	14.36
End Levee Mile	14.38
Location	Land Side
Category	Earthen Levee
Item	Vegetation
Looking west at landscaping on landside slope.	
richard_s_20120328_177.jpg

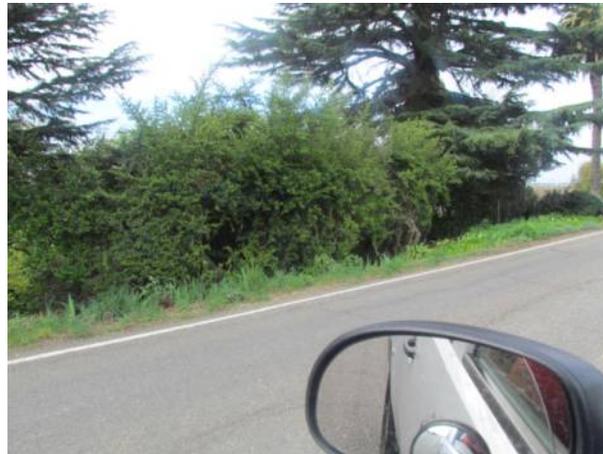
Levee Mile Report Line	76
Start Levee Mile	14.93
End Levee Mile	15.09
Location	Land Side
Category	Earthen Levee
Item	Vegetation
Looking northwest a dense landscaping on landside shoulder and slope.	
richard_s_20120328_178.jpg

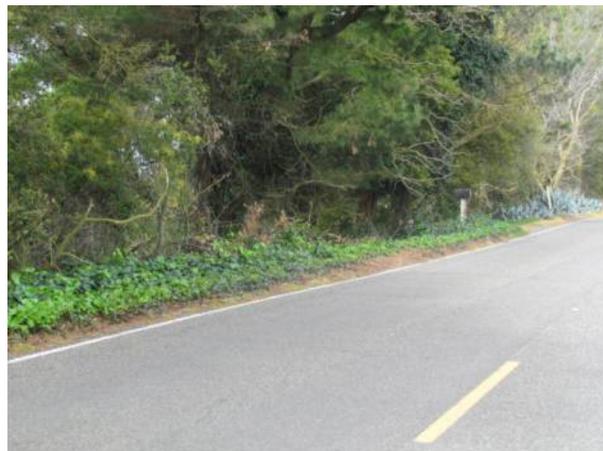
Levee Mile Report Line	78
Start Levee Mile	15.84
End Levee Mile	15.93
Location	Land Side
Category	Earthen Levee
Item	Vegetation
Looking south at landscaping on levee slope and toe obstruct access and visibility.	
richard_s_20120313_373.jpg
